# Cultural Heritage Evaluation

## Picton Courthouse 50 Union Street

## Prince Edward County, Ontario

### Draft Report

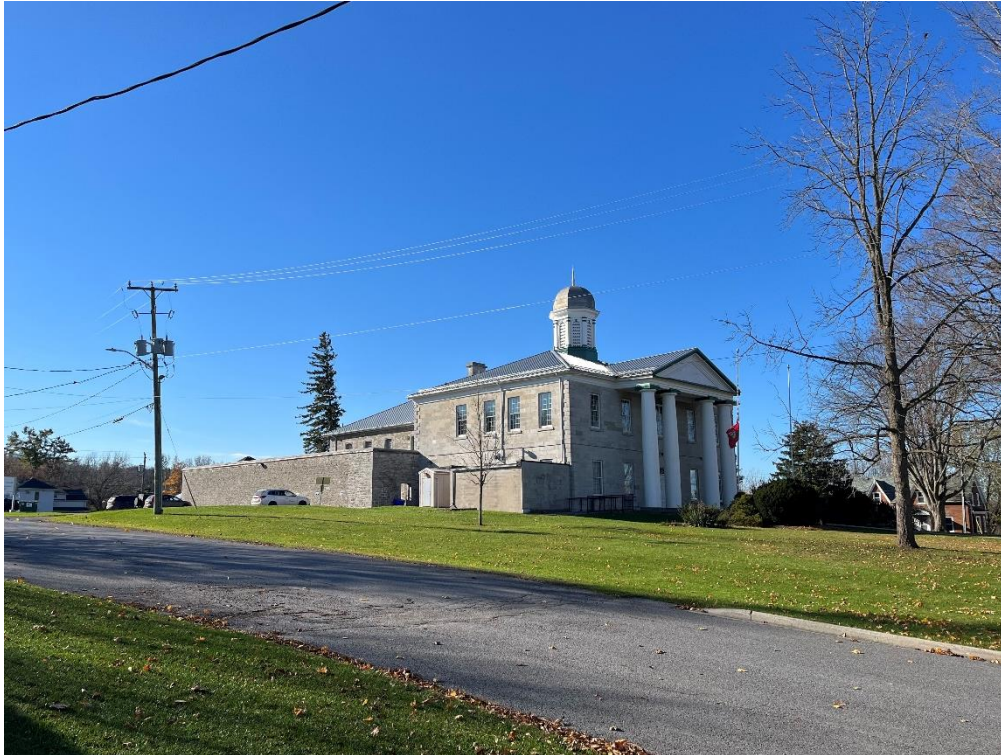
Figure 2: The subject property (A.S.I., 2023)

The Picton Courthouse property features a judicial complex in a landscaped setting that contains a grouping of interconnected nineteenth- and twentieth-century buildings (Figure 2). The courthouse building, which fronts Union Street, was constructed in 1834 in a Georgian style. Additional features, such as the portico and cupola were added in the 1840s and 1860s. A jail extension was constructed from 1867 to 1868, including the addition of stone walls to form jail yards. The courthouse and jail are two-storey limestone buildings that form a T-shaped footprint. In 1975 a Land Registry Office was integrated into the west jail yard (Figure 4). The property has continued to serve as a courthouse since its construction in the mid nineteenth century, though the jail is no longer in service. Holdings from the Prince Edward County Archives are currently being stored within the former jail. The Land Registry Office is currently occupied by Service Ontario. The judicial complex is located on an approximately two-acre

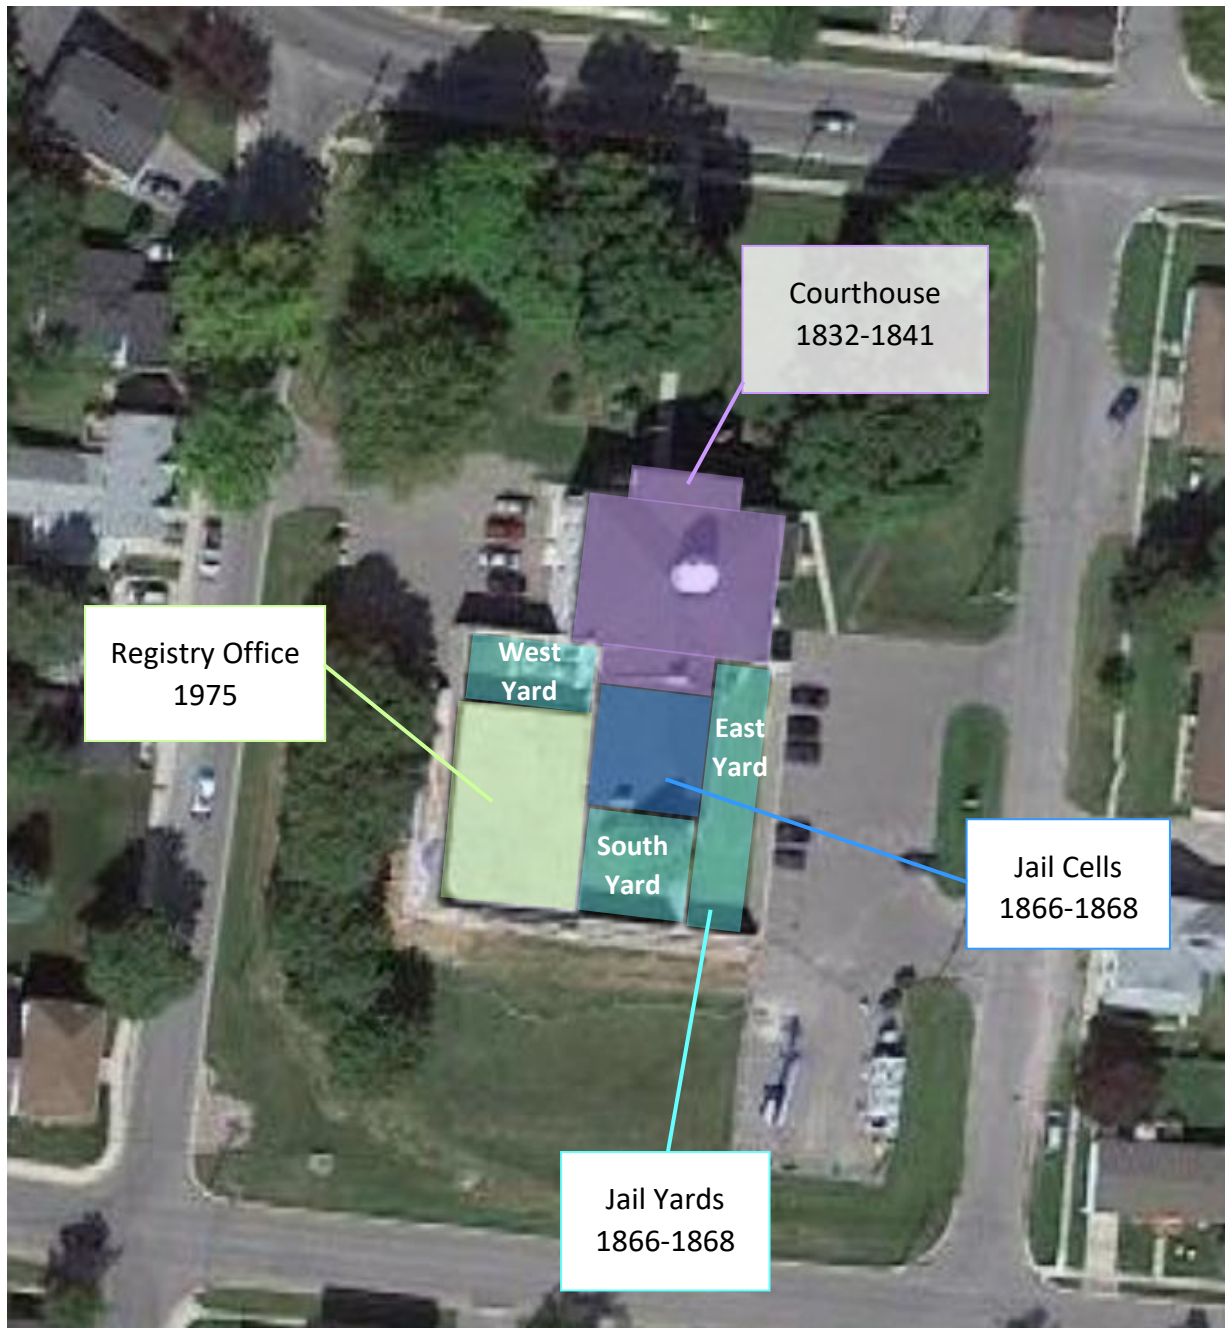
Figure 22: Satellite image of the subject property annotated to illustrate the components of the judicial complex with date of construction indicated.

The arrangement of these interconnected components are illustrated in Figure 22.

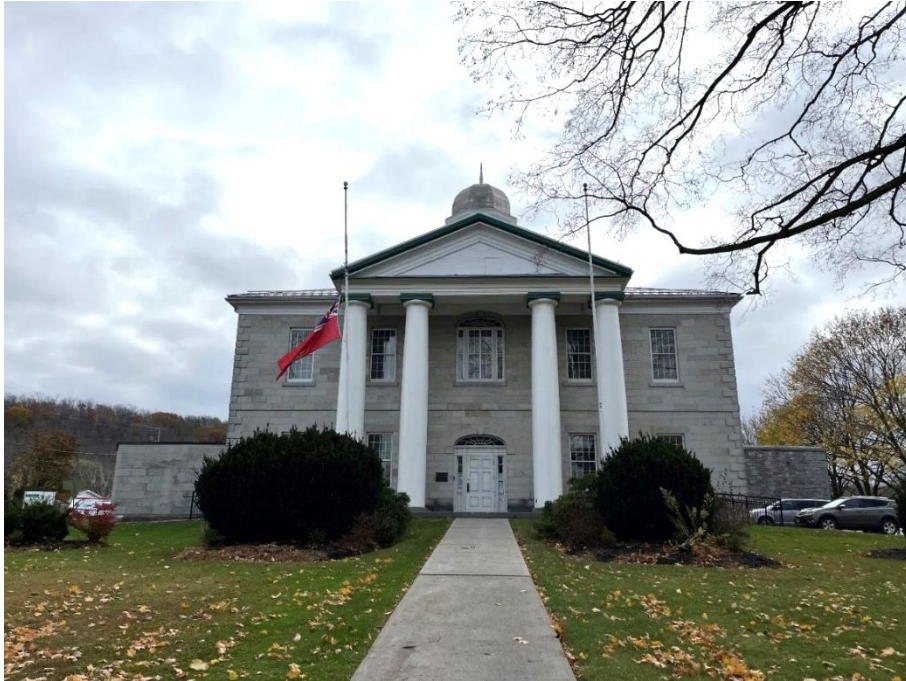
Figure 30: The primary elevation of the Picton Courthouse

The 1832-1834 courthouse building is a two-storey cut Kingston limestone building with symmetrical façade featuring five bays and central primary entrance (Figure 30). The hipped roof with central cupola – added in the 1860s – features standing seam metal roofing that is not original to the building but follows the original building material. Giant order columns support a portico centred over the primary entrance. The extant columns are replacements of earlier wood columns, though they generally follow the original form and placement. A wood frieze with subtle dentil ornamentation wraps the building beneath the roof overhang and carries into the entablature of the portico (Figure 32). The exterior of the building features ashlar limestone with stone quoining and ornamental stone band dividing the two storeys (Figure 31).

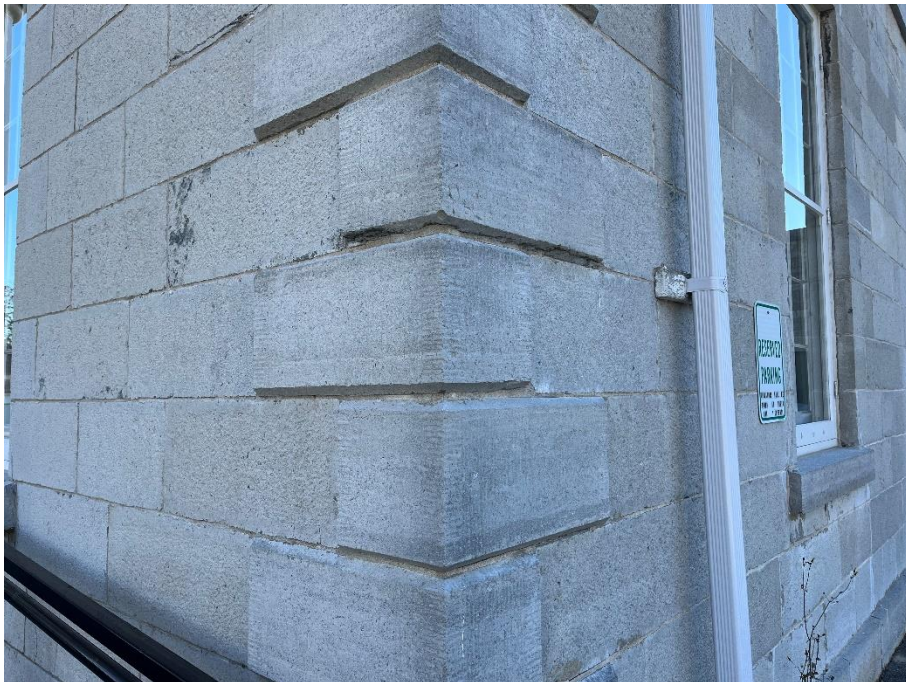
Figure 31: Detail of limestone quoining (A.S.I. 2023).

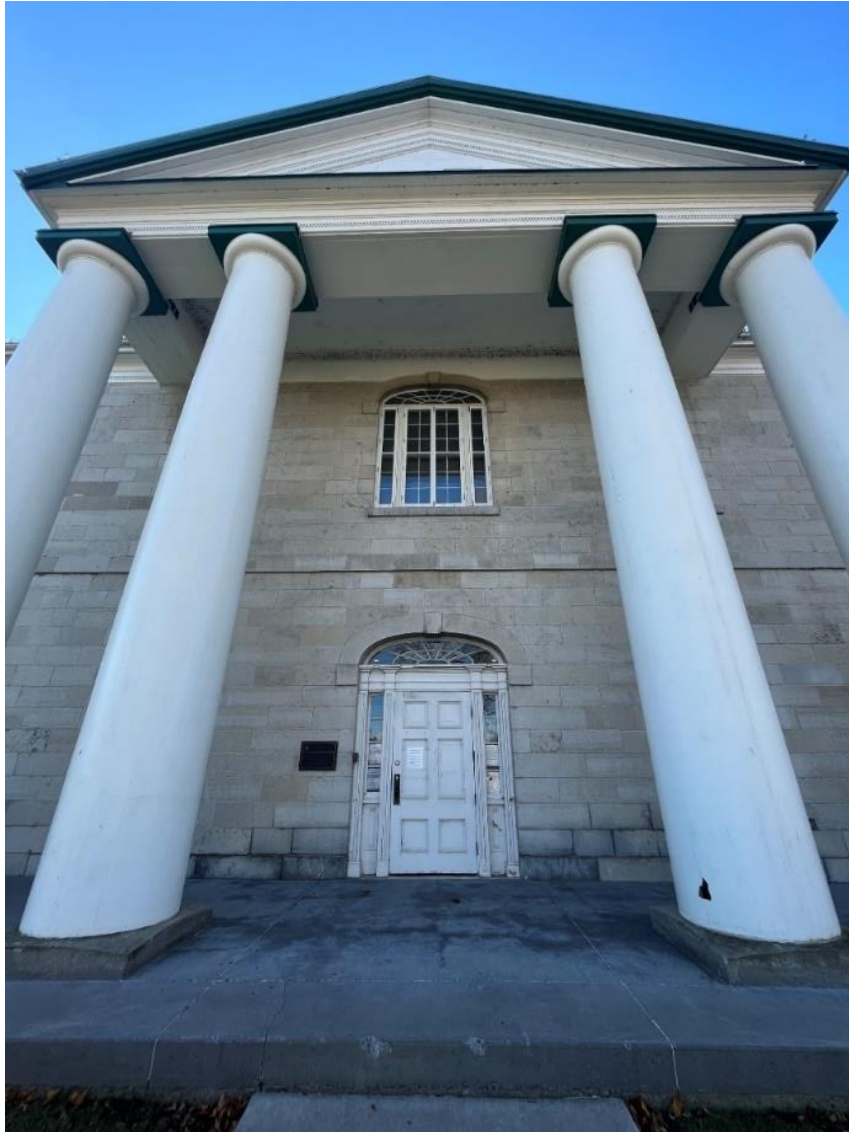
Figure 32: Detail of the portico added to the Georgian style courthouse by 1841. The giant order columns were replaced in 1993.

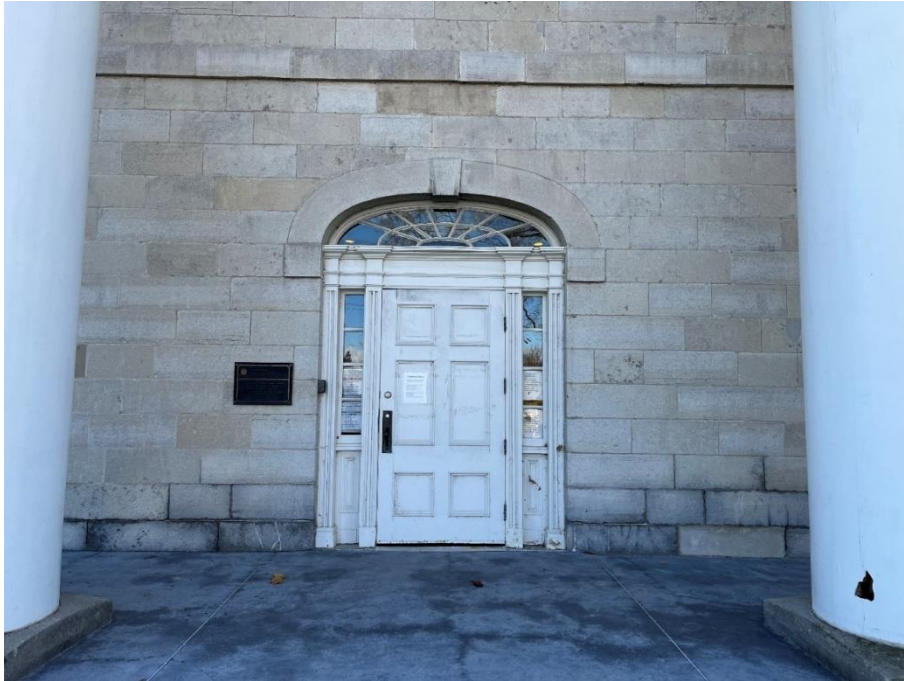
Figure 33: Detail of the primary entrance with original surround and replacement door (A.S.I., 2023).

The fanlight and surround of the primary entrance are intact, though the door has been replaced (Figure 33). The second-storey window above the entrance echoes the elliptical arch of the door opening below, contrasting the remaining windows with flat heads (Figure 34). There is a secondary entrance on the east elevation as well as a basement access. Windows throughout the building feature cut limestone sills, multi-light sash, and generally follow their original rectangular openings with the exception of a partial infill on the west elevation and additional infill on the south addition near the jail and Land Registry Office additions (Figure 35). The infill material matches the limestone of the exterior walls.

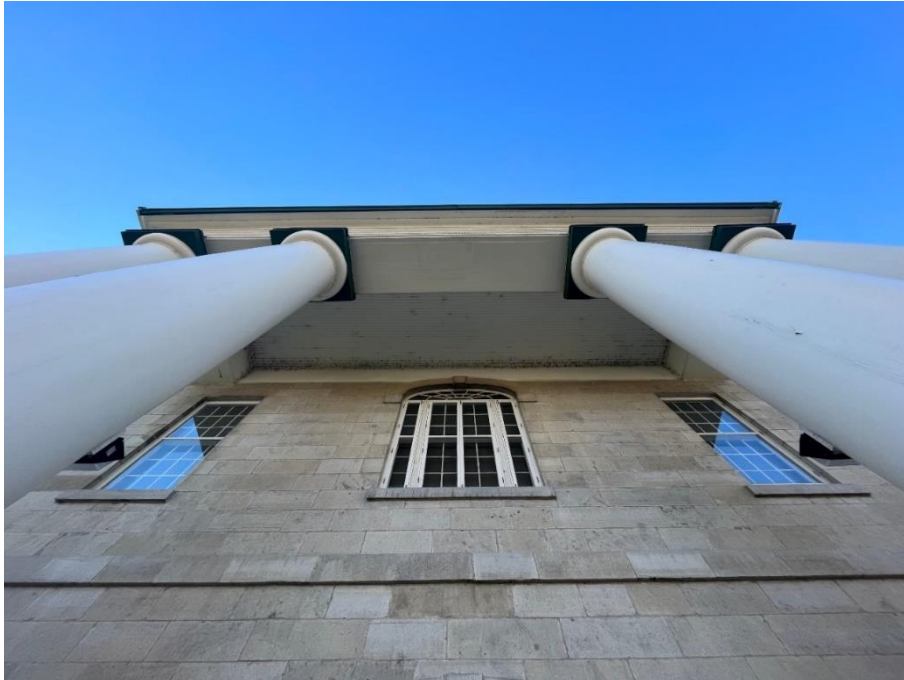
Figure 34: Detail of second storey, including the centre window with fan light (A.S.I. 2023).

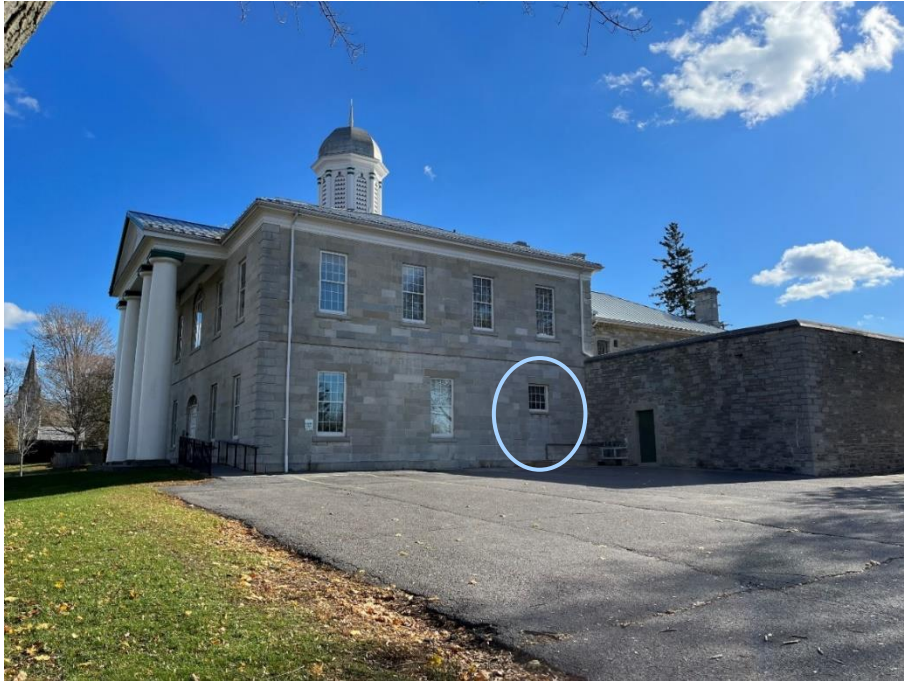
Figure 35: West elevation showing regular placement of window openings, with the exception of one that has been partially infilled (circled) (A.S.I. 2023).

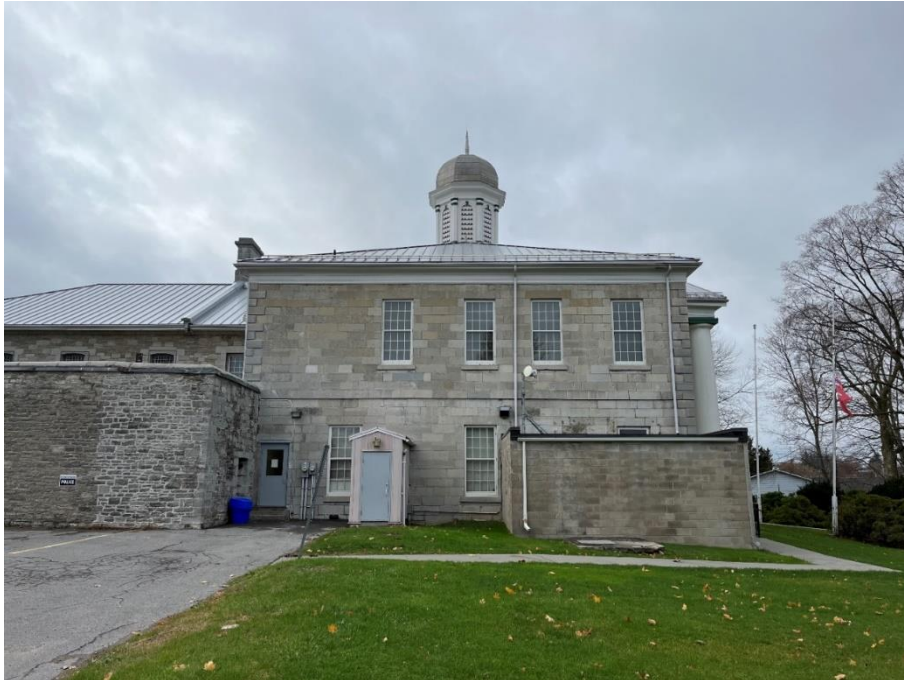
A small, one-storey addition built using concrete blocks on the east elevation of the courthouse. Based on the materials, design, and historical photographs of the property, it was likely constructed in the middle of the twentieth century. The north wall of the addition is clad with cut stone veneer and runs flush with the north-facing stone wall of the courthouse (Figure 36). The other minor addition on the east elevation is a small, metal-clad shed that provides cover for the basement access door.

Figure 36: View of the east elevation showing the one storey concrete block addition and shed cover for the basement access (A.S.I. 2023).

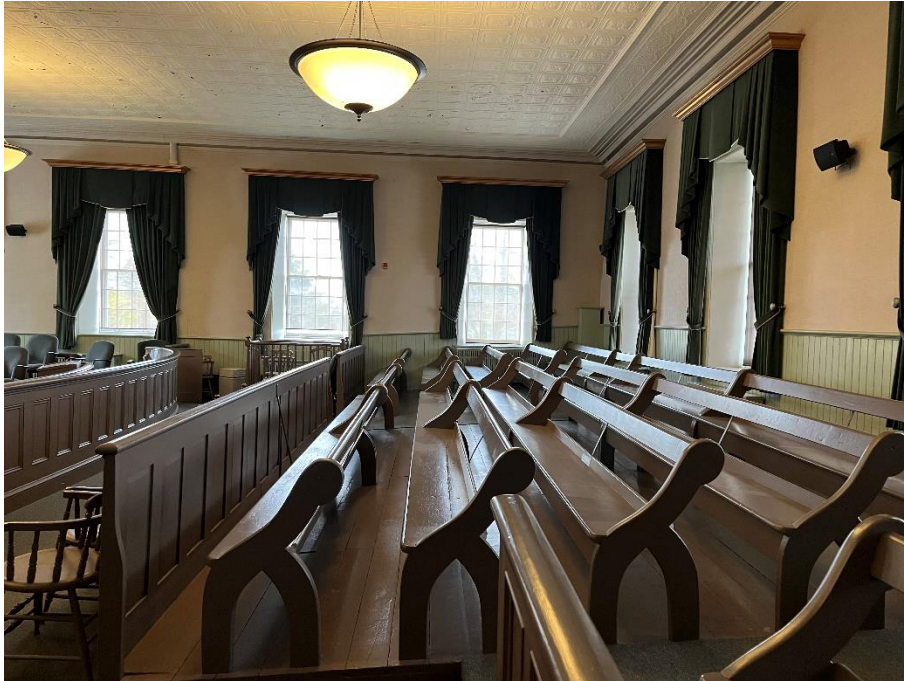
Figure 44: Second Floor – Sloped spectator seating in main courtroom (A.S.I., 2023).

- Decorative cast iron grille in the ceiling
- Pressed tin ceiling
- Ventilation system – through ceiling grille to cupola and boxes between windows
- Plaster, applied during the 1860s renovation
- Ramped spectator seating (Figure 44)
- Interior doors and casing from 1830s (Figure 45)
- Painting of the Royal Coat of Arms (William Hale painted in 1834) still hangs on the wall behind the judge's dais in the main courtroom
- Furnishings in the main courtroom, including the long elliptically-curved bench in the centre of the room, two of three magistrate seats (backs removed and relocated), judge's and clerk's desk from the 1860 renovation, witness box to the left of the judge, counsel tables, and Windsor jury chairs

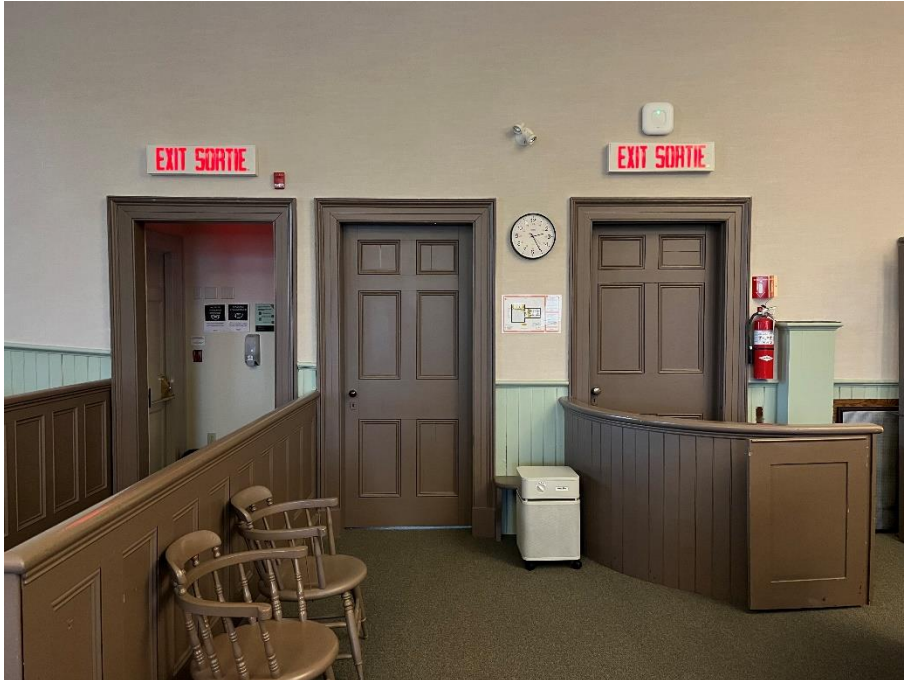
Figure 45: Second Floor – Series of openings showing original doors and casings in the main courtroom (A.S.I., 2023).

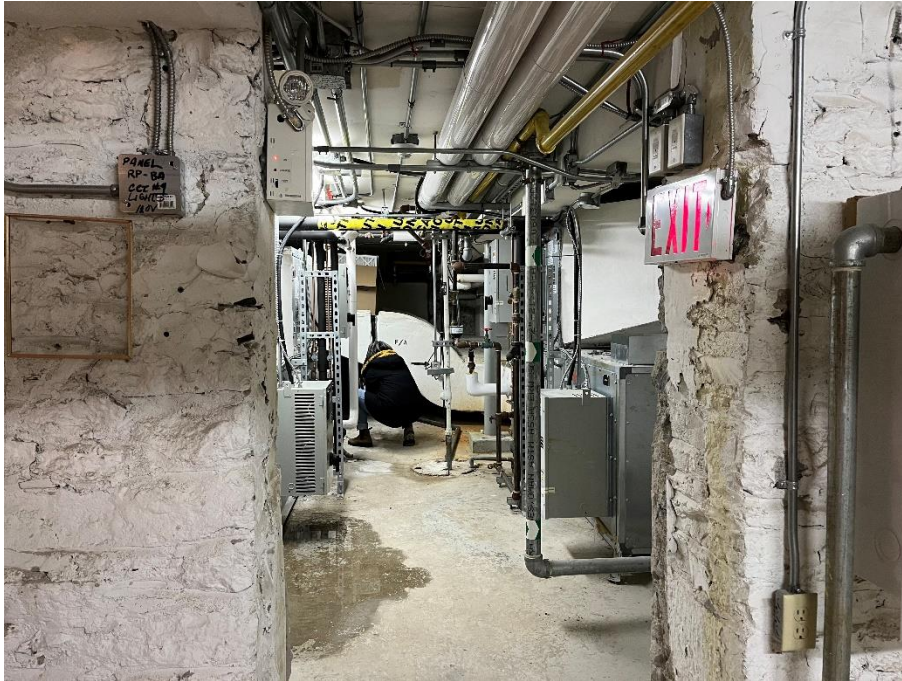
Figure 46: View within the basement showing the stone foundation and network of internal building systems exposed (A.S.I., 2023).

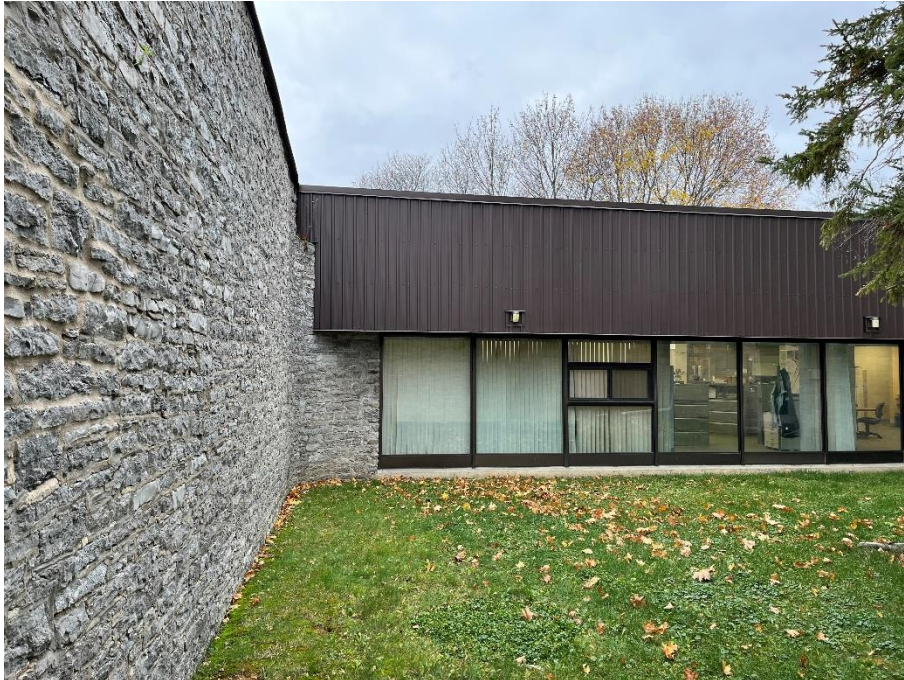
Figure 49: South wall of jail yard curving before it connects with the 1975 Land Registry Office addition (A.S.I., 2023).

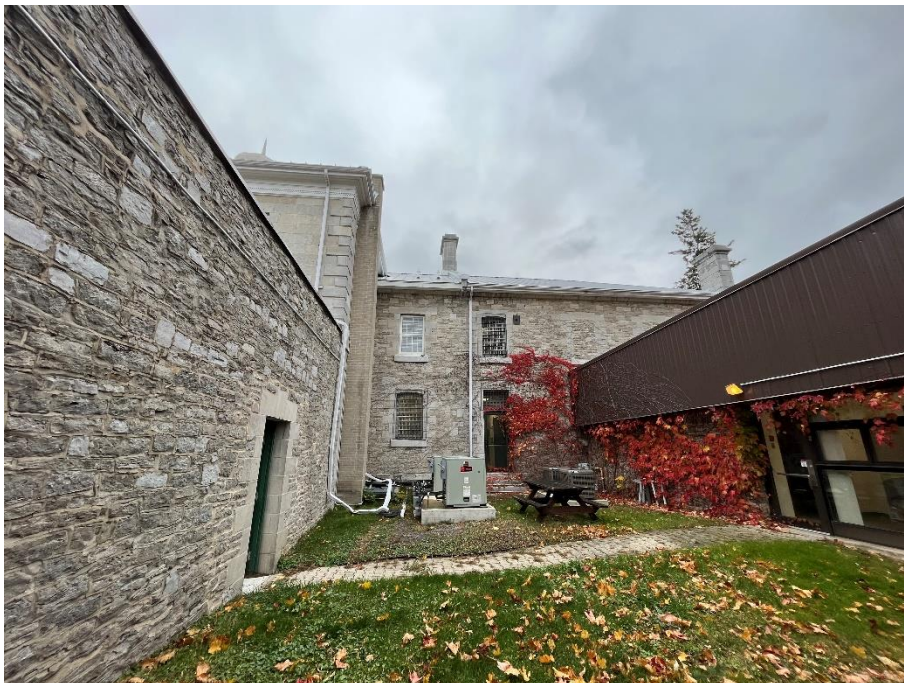
Figure 51: Looking east in the west jail towards the jail addition (centre), courthouse (left) and Land Registry Office (right), and well as many of the building utilities located within the yard.

open area in the west yard features ventilation and utilities systems (Figure 51). The other two yards feature open grassed yard. The south yard additionally contains a pine tree and the stump of a second tree within the yard (Figure 50). The south and east yards are connected through a wood door. The walls that form the jail yards have sharp corners on the exterior, but are rounded at the corners on the interior (Figure 52). The exterior walls of the jail yard walls are the same stack of limestone. The northeast corner appears to be repointed, but otherwise the original mortar appears to be intact (Figure 53 and Figure 55).

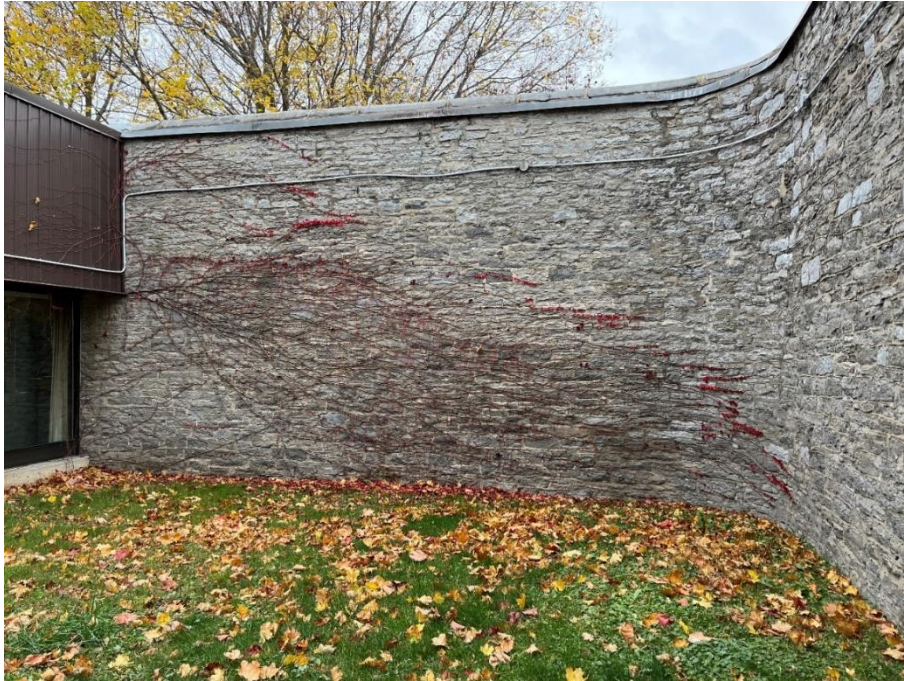
Figure 52: Detail of the curved interior corner of the jail yard, typical within each of the internal yards in the complex (A.S.I., 2023).

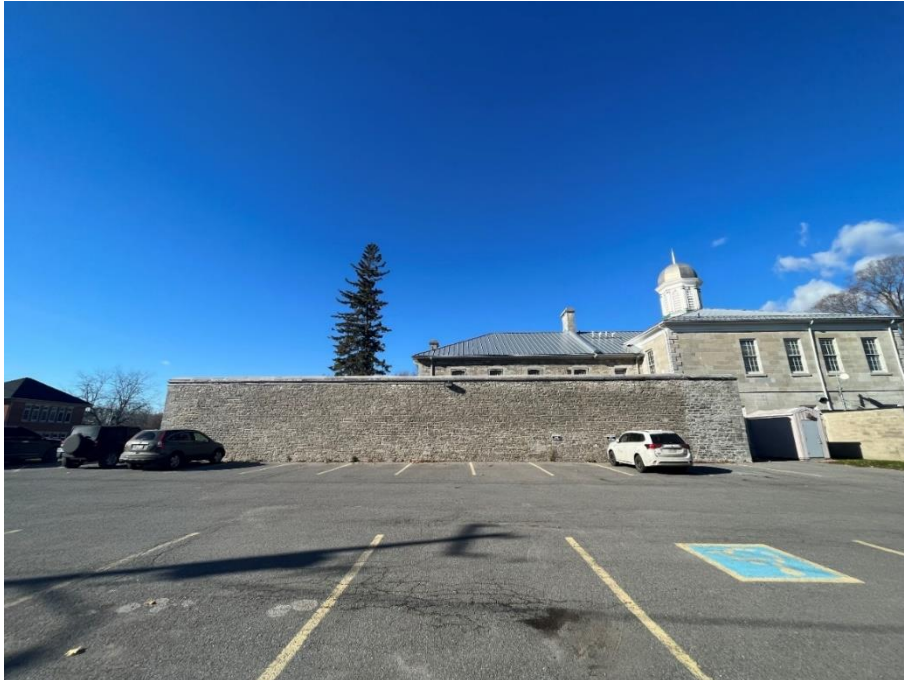
Figure 53: East elevation of exterior jail yard wall (A.S.I., 2023).

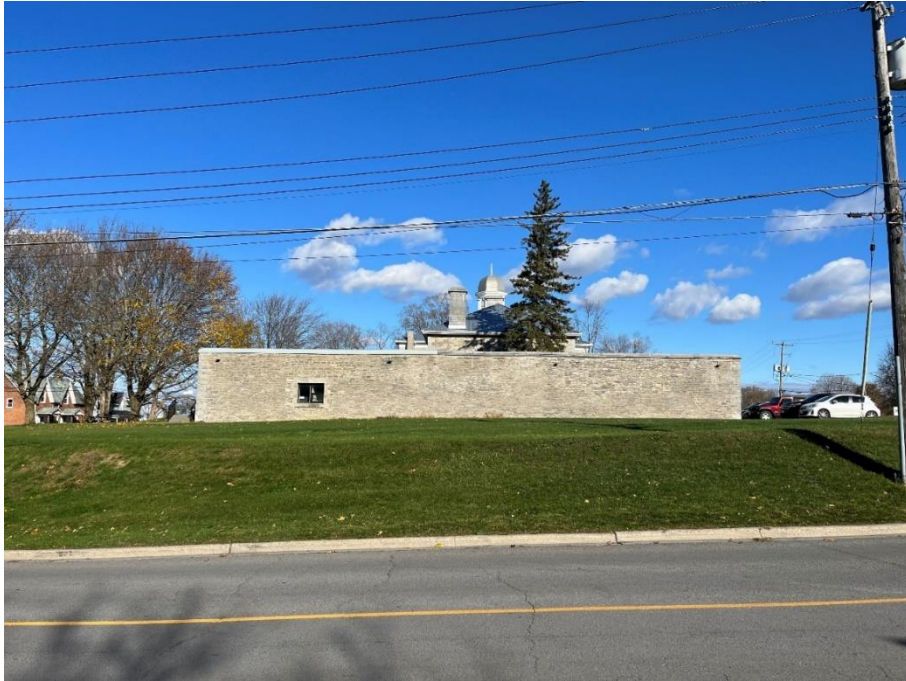
Figure 54: South elevation of exterior jail yard wall (A.S.I., 2023).

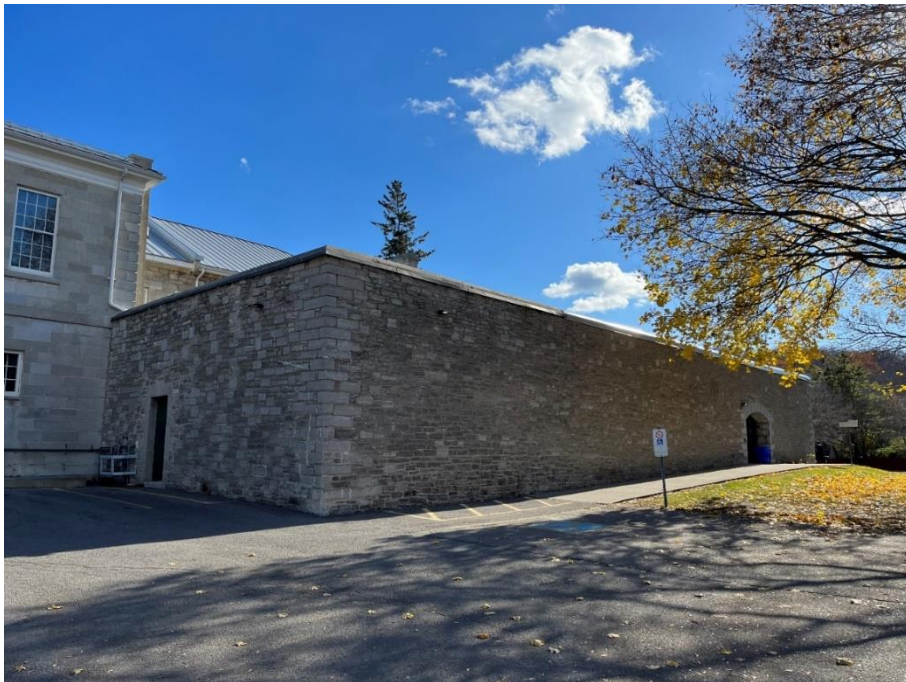
Figure 55: North and west elevation of exterior jail yard walls (A.S.I., 2023)

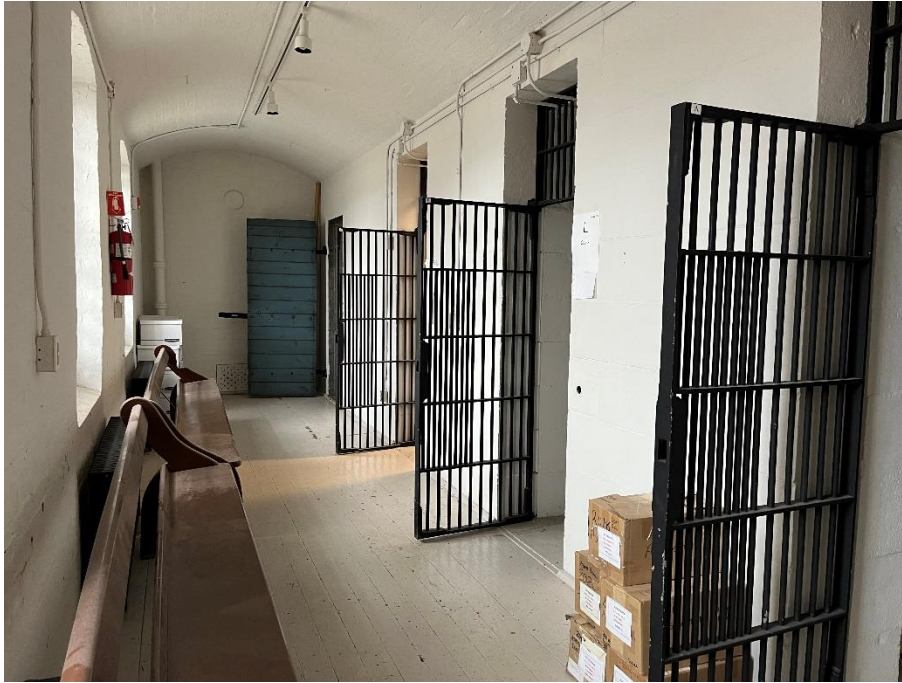
Figure 56: Typical jail corridor featuring jail cells with barred doors along the centre of the addition with a passageway and windows around the perimeter of the cell block A.S.I., 2023).

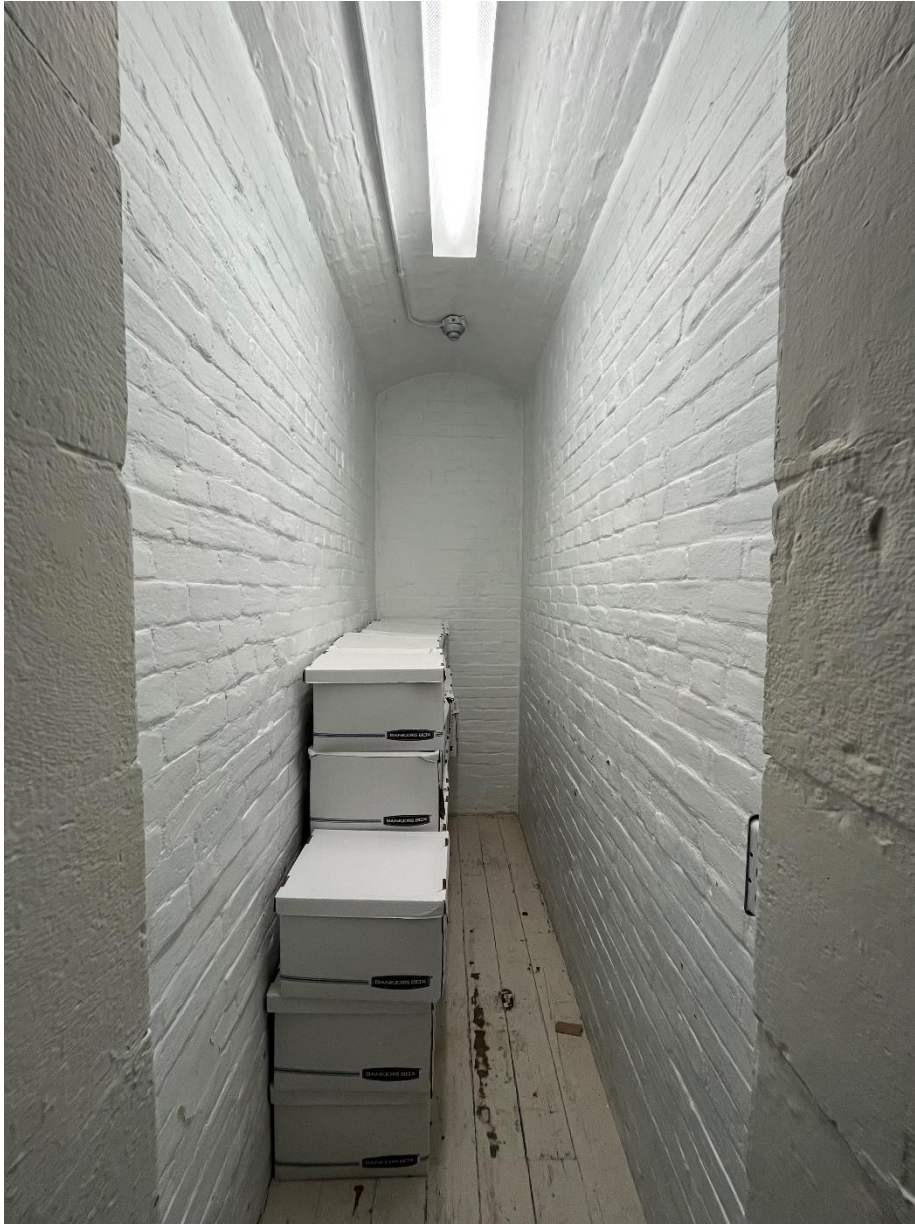
Figure 57: Example of a typical jail cell featuring barrel vaulted ceiling, brick walls, and wood floors. The size of the cell was determined by the occupant and nature of the crime committed, with similar sized cells grouped together (A.S.I., 2023).

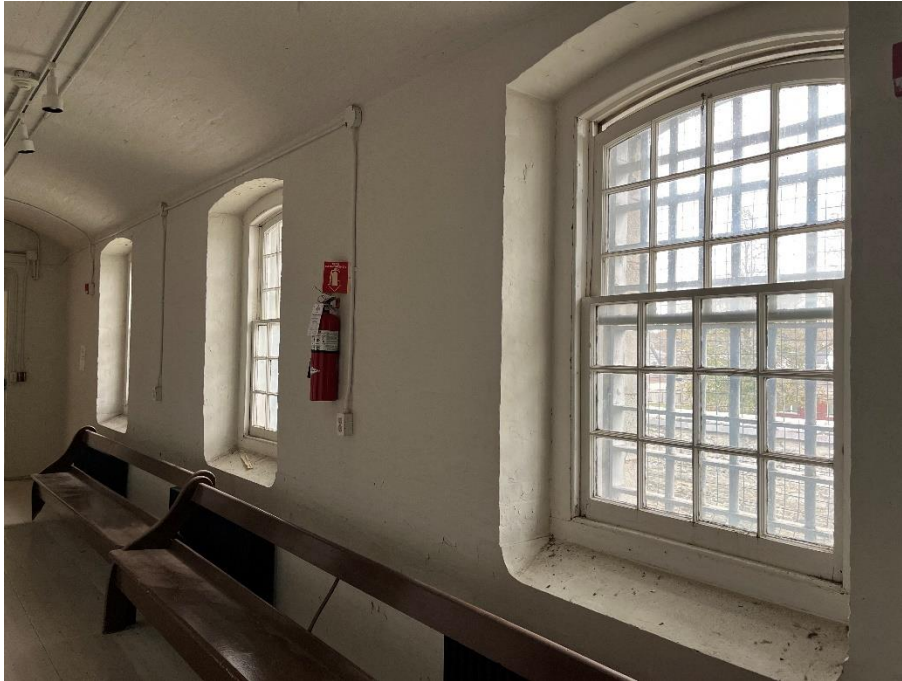
Figure 58: Detail of the 12-over-12 sash windows that are still extant throughout the two-storey building (A.S.I., 2023).

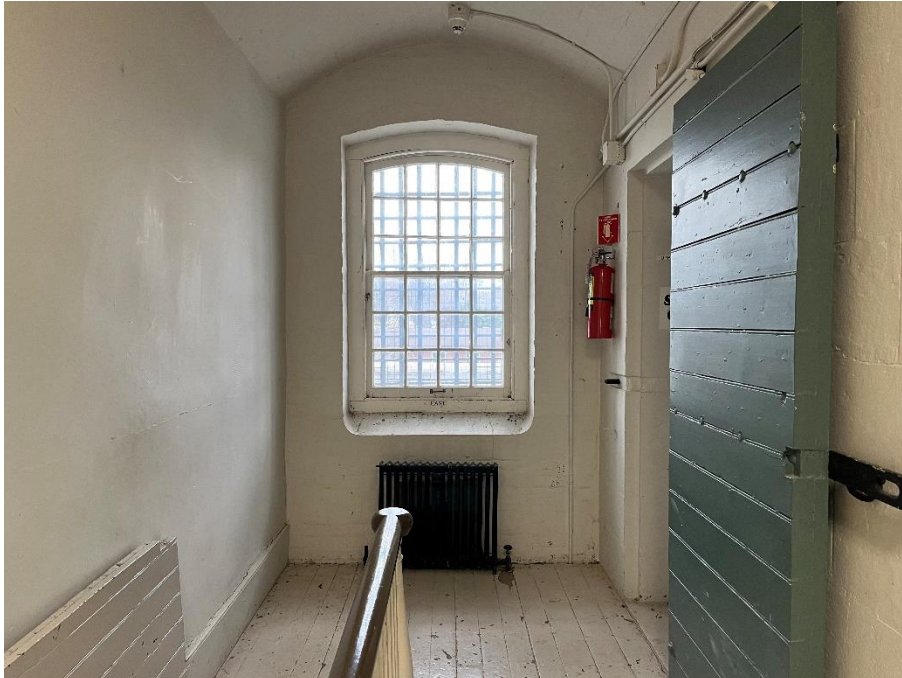
Figure 59: Detail of the second floor north corridor showing the original window, wood door, wood floors, and balustrade for the stairs leading to the first floor (A.S.I., 2023).

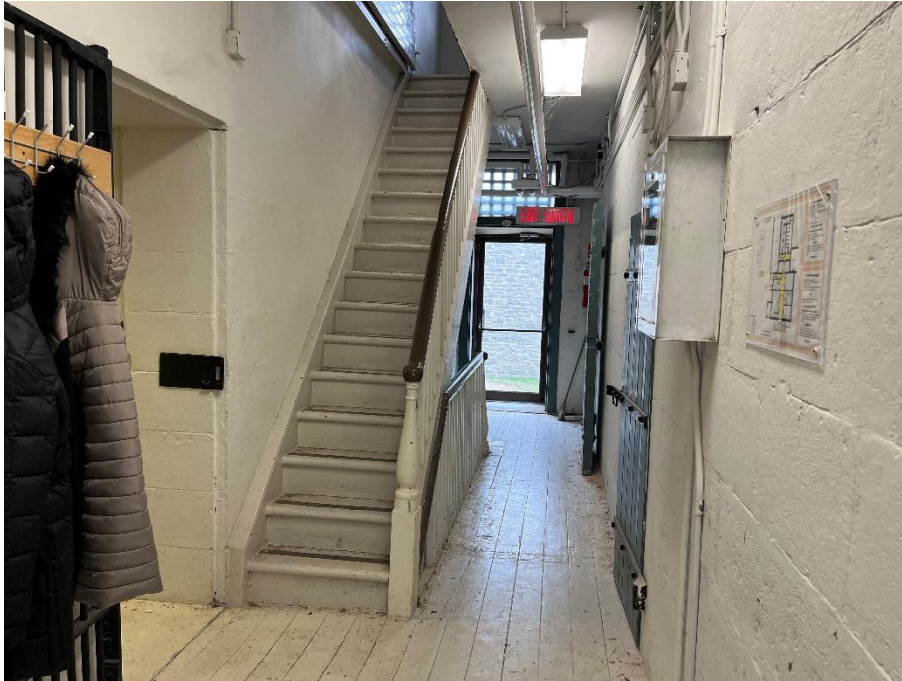
Figure 60: Detail of the first-floor north corridor showing the intact stairs with newel post and balustrade (A.S.I., 2023).

- Limestone cell partitions with barrel vaulted ceilings
- Iron bars
- Wooden doors (Figure 59)
- Elliptically arched window openings, many still maintaining the 12-over-12 sash (Figure 58)
- Staircases with wood newels and balusters (Figure 60)
- Wood floors
- Alterations to accommodate gallows within the south passageway, which include the opening in the floor and introduction of wood gallows<sup>5</sup> (Figure 61)<sup>6</sup>

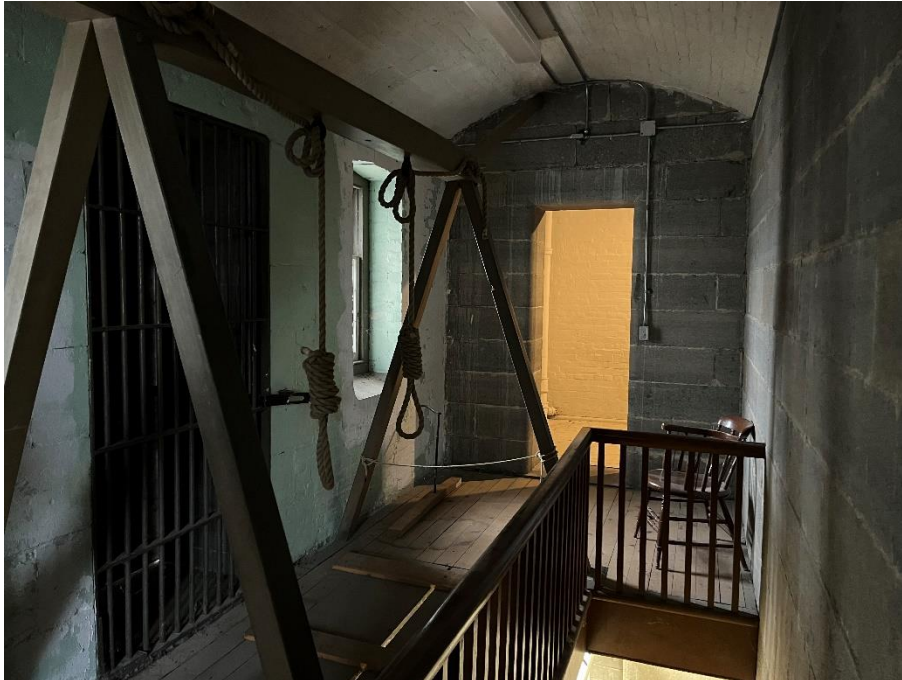
Figure 61: Detail of the alterations to the south passageway to accommodate the double hanging that occurred there in 1884 (A.S.I., 2023).

Gallows are constructed in the rear passageway of the jail, which are used for the double hanging in 1884. Openings in the south wall of the jail in the first and second storeys provide viewed into the gallows (Figure 78).

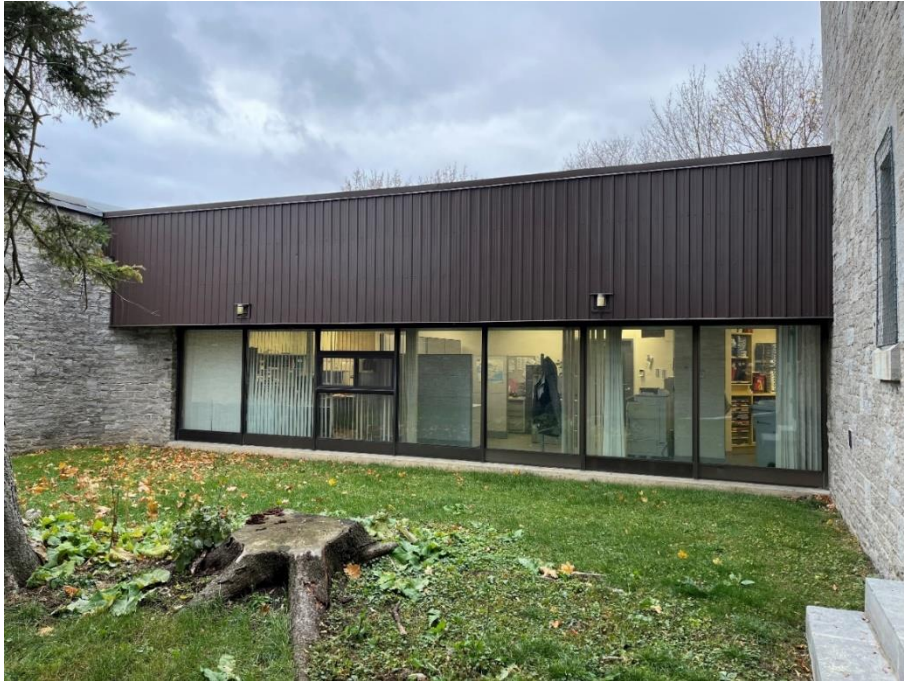
Figure 63: East elevation of the office, visible within the south jail yard (A.S.I., 2023).

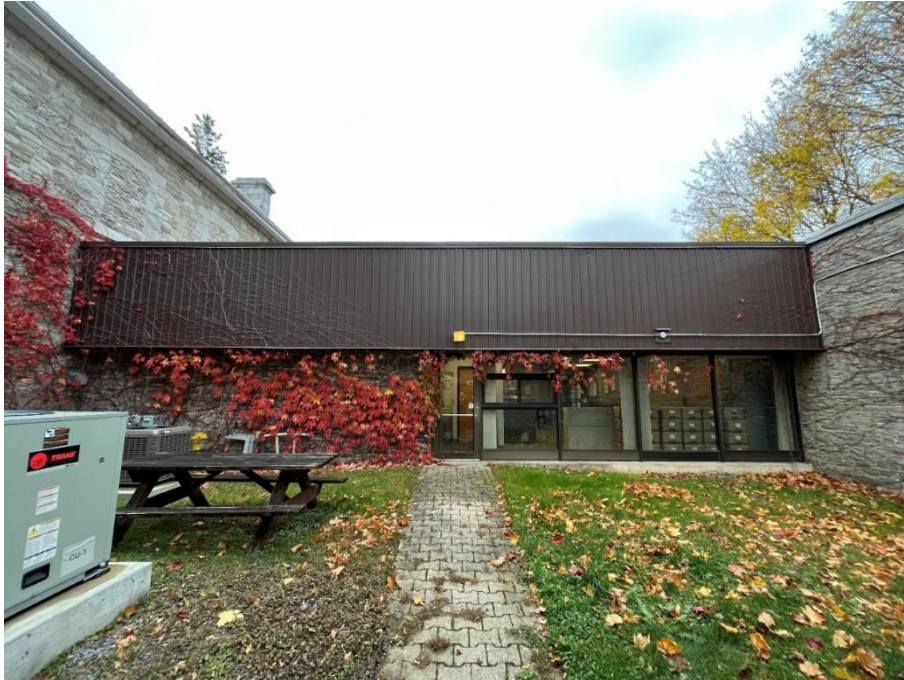
Figure 64: North elevation of the office, looking south from the secondary entrance to the west jail yard (A.S.I., 2023).

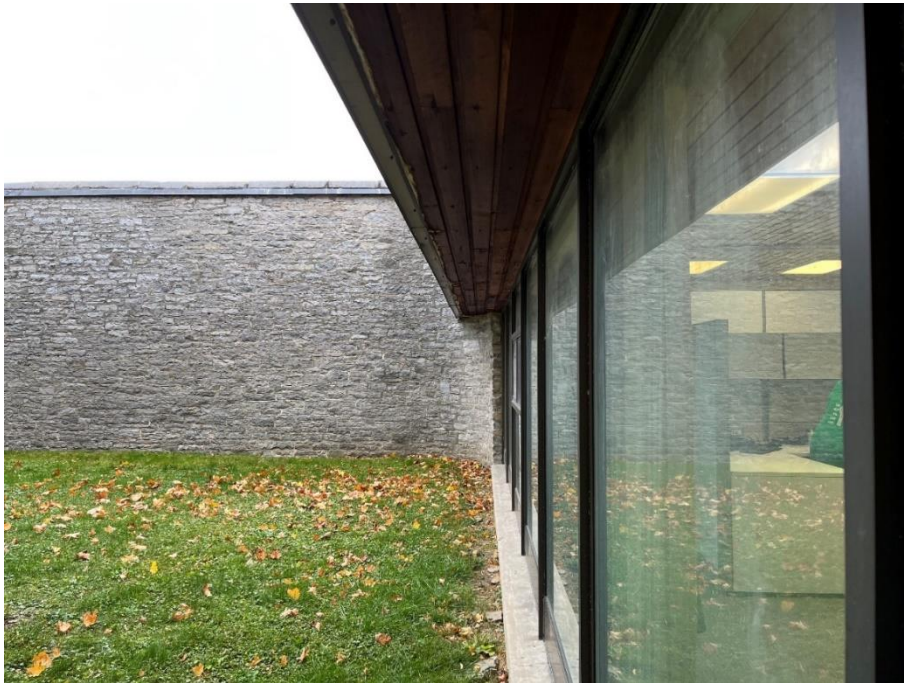
Figure 65: Detail of wood panelled soffit and exterior glazing (A.S.I., 2023).

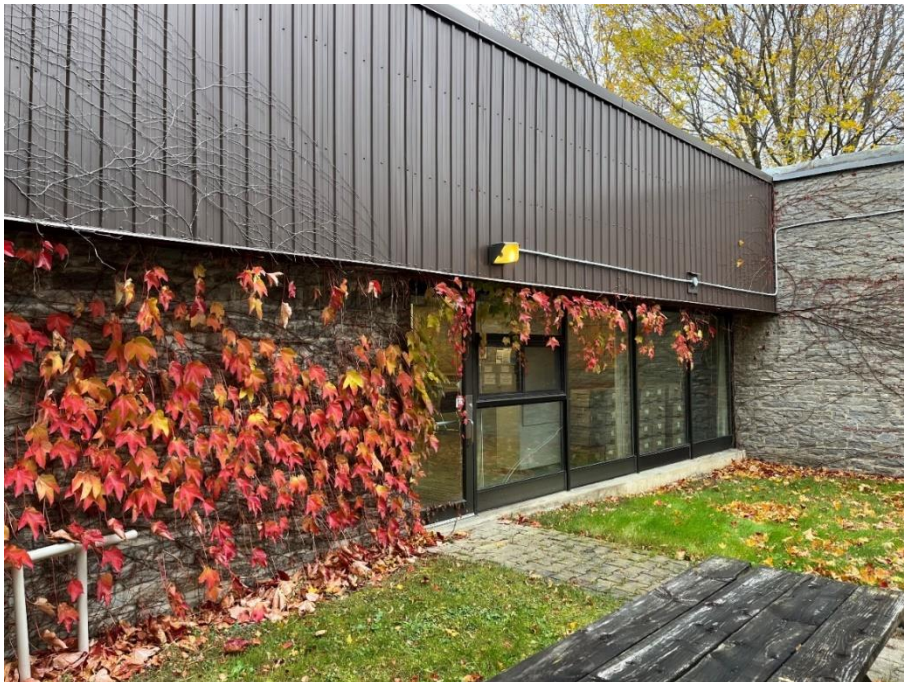
Figure 66: Detail of stone cladding and exterior glazing on the north elevation (A.S.I., 2023).

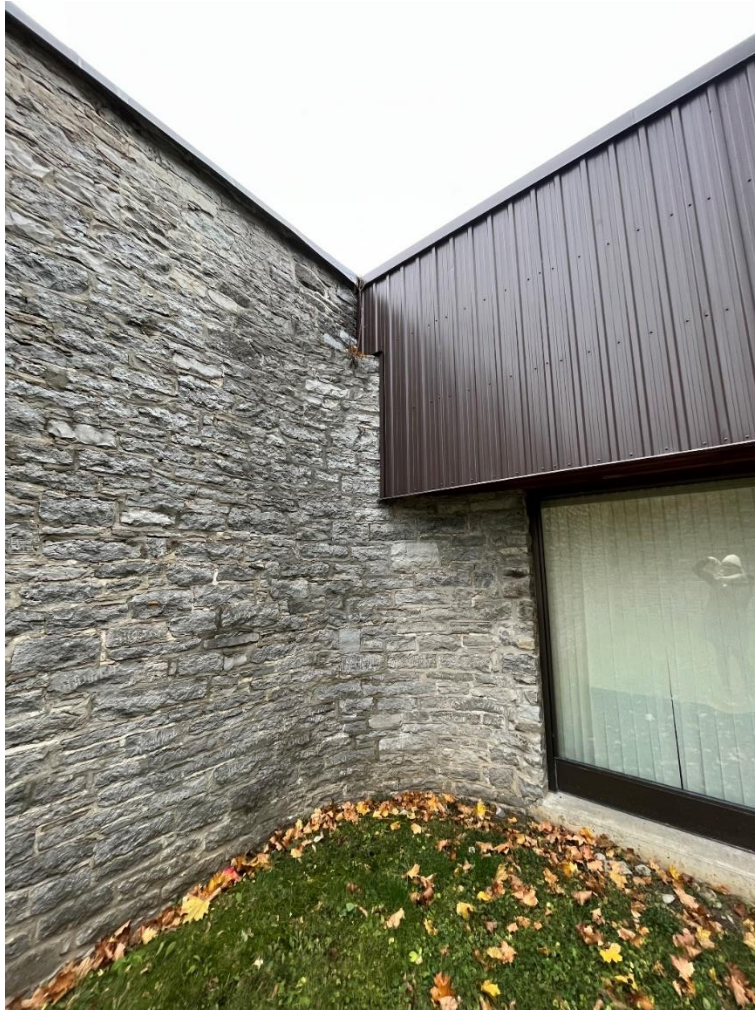
Figure 67: Detail of the stepped integration of the office addition into the original curved walls of the jail yard (A.S.I., 2023).

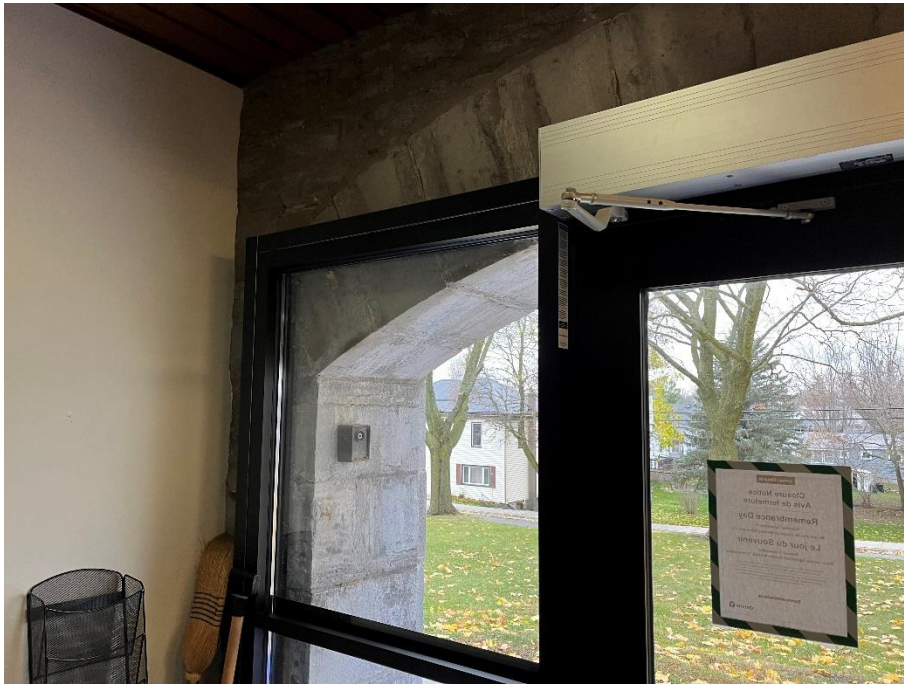
Figure 68: Detail of the placement of the entrance to the Land Registry Office addition against the nineteenth-century opening without altering the opening (A.S.I., 2023).
