# Cultural Heritage Evaluation

## Picton Courthouse 50 Union Street

## Prince Edward County, Ontario

### Draft Report

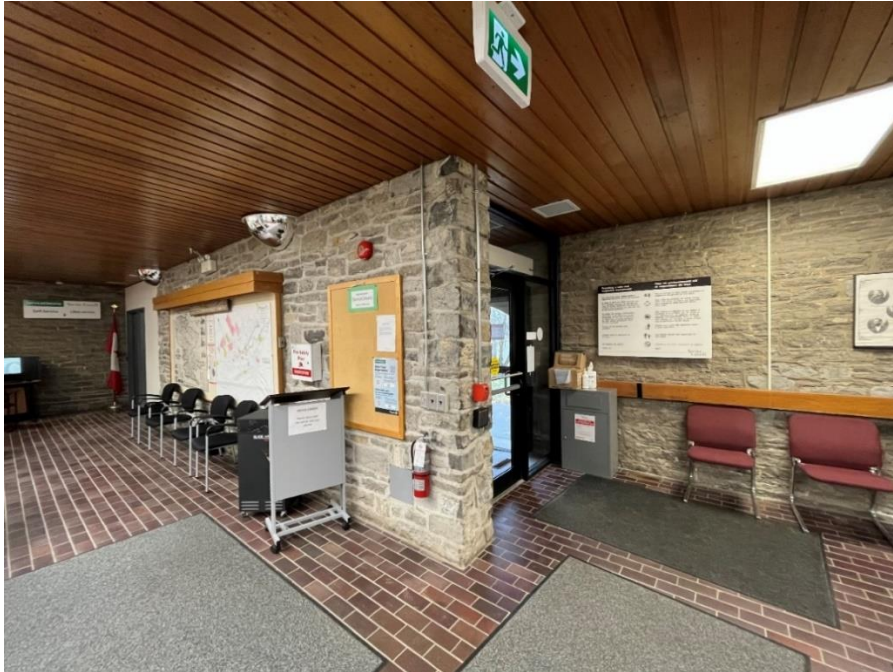
Figure 69: Main office space within the addition, looking towards the primary entrance where limestone walls are incorporated into the interior space (A.S.I., 2023).

The primary entrance to the Land Registry Office leads to a small foyer space where the integration of the 1975 building against the surrounding nineteenth-century jail yard walls are visible within the steel and glass structure (Figure 68). The main, public, office space is accessed off the foyer, where additional limestone walls have been incorporated into the design of the addition (Figure 69). The main office space also features wood panelled ceiling and tile floors. Cubicles and service staff partitions are moveable features within the interior (Figure 70).

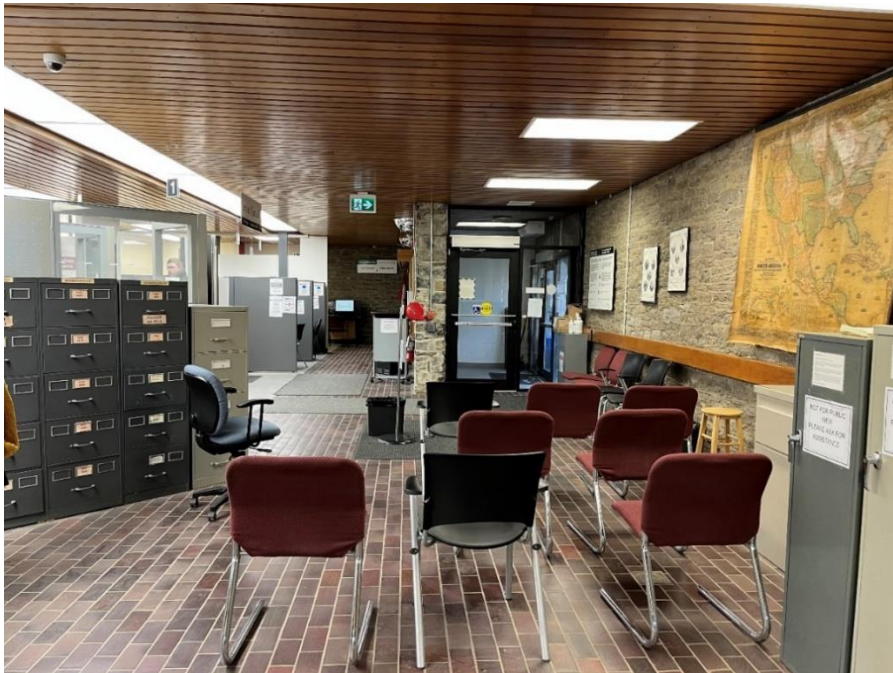
Figure 70: The office interior features wood paneled ceiling, limestone and typical twentieth-century drywall, and a tiled floor. Office and cubicles are moveable structures (A.S.I., 2023).

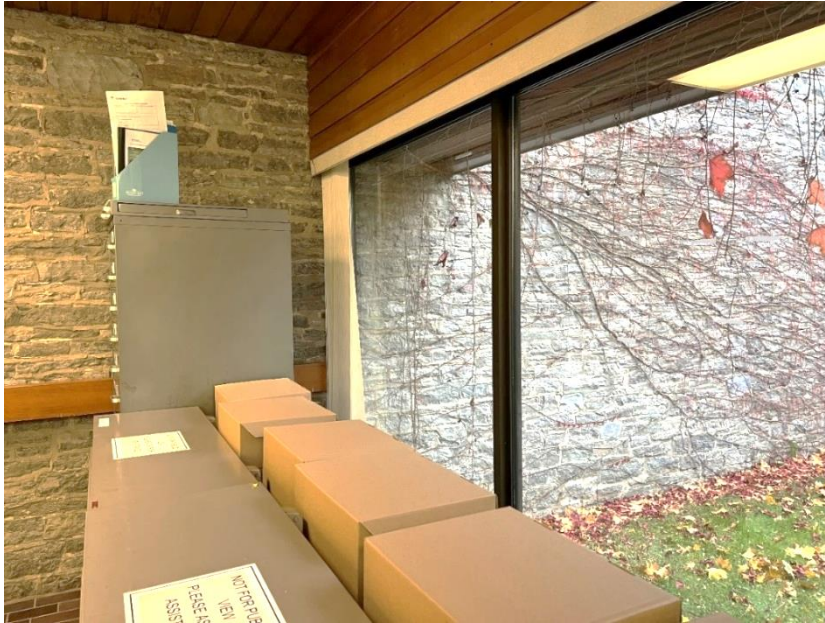
Figure 71: Detail of the affect of the expanse of glazing on the exterior, which visually connects the building to the jail yards (A.S.I., 2023).

The expanse of glazing on the exterior walls provides uninterrupted views into the surrounding jail yards, visually connecting the two spaces (Figure 71). Staff office spaces are also built to integrate into the nineteenth-century stone walls and works spaces are defined by non-permanent cubicles (Figure 72).

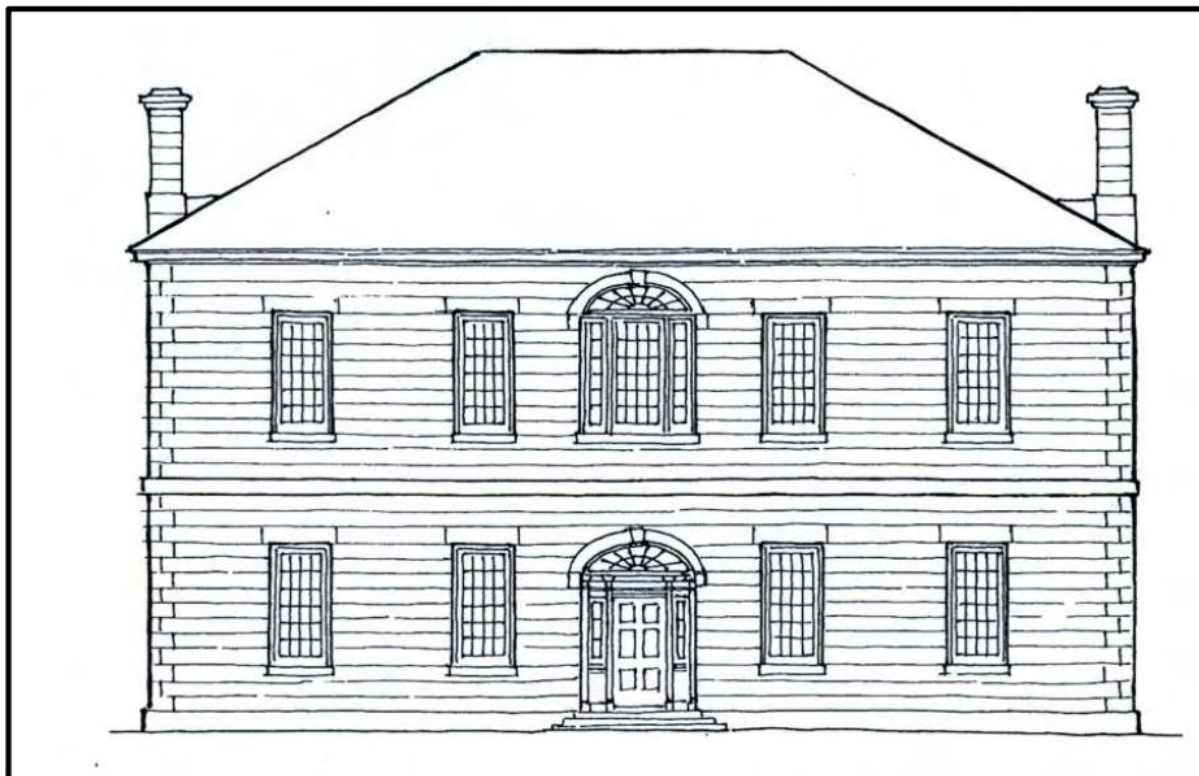
Figure 73: Primary elevation of the Picton Courthouse drawn as it likely appeared in 1834 (MacRae's *Cornerstones of Order*, sketch by Anthony Adamson, 1983).

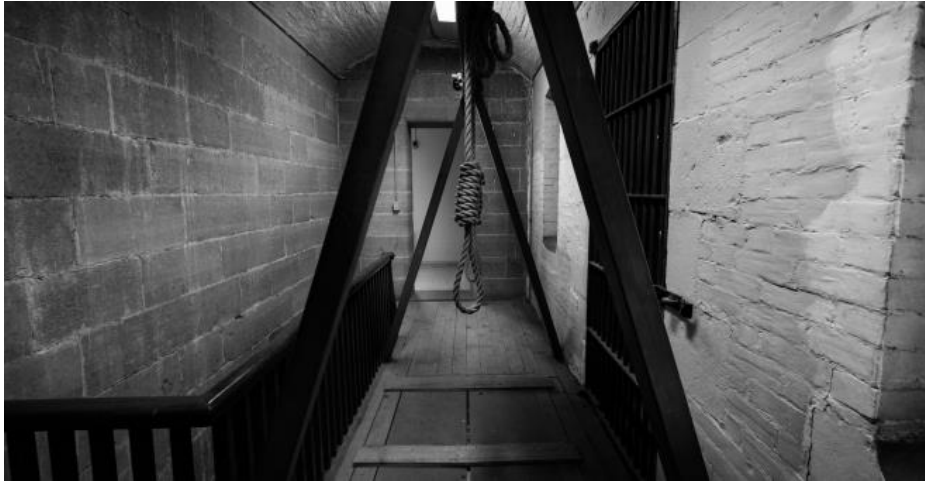
Figure 78: Gallows constructed in the second storey passageway of the south end of the jail (Ontario Museums).

Gallows are constructed in the rear passageway of the jail, which are used for the double hanging in 1884. Openings in the south wall of the jail in the first and second storeys provide viewed into the gallows (Figure 78).

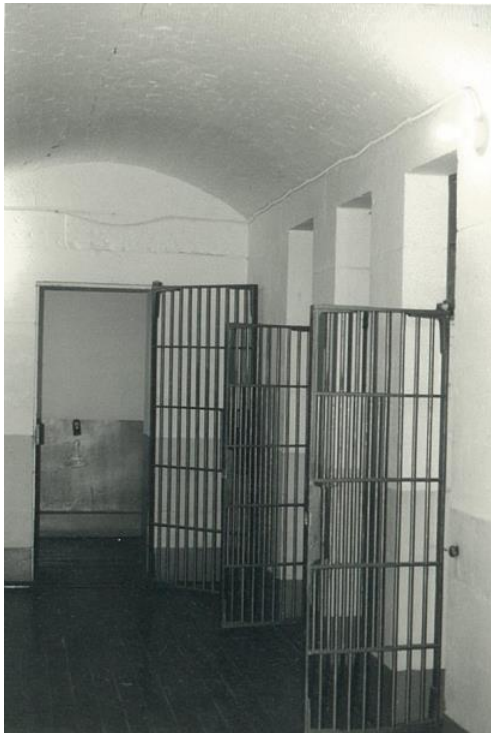
Figure 79: Prison cells in the jail addition photographed circa 1980 (Prince Edward County Archives)

The jail is decommissioned, but cells remain intact (Figure 79). Latches were removed from the cell doors over time, but barred doors remain in place.

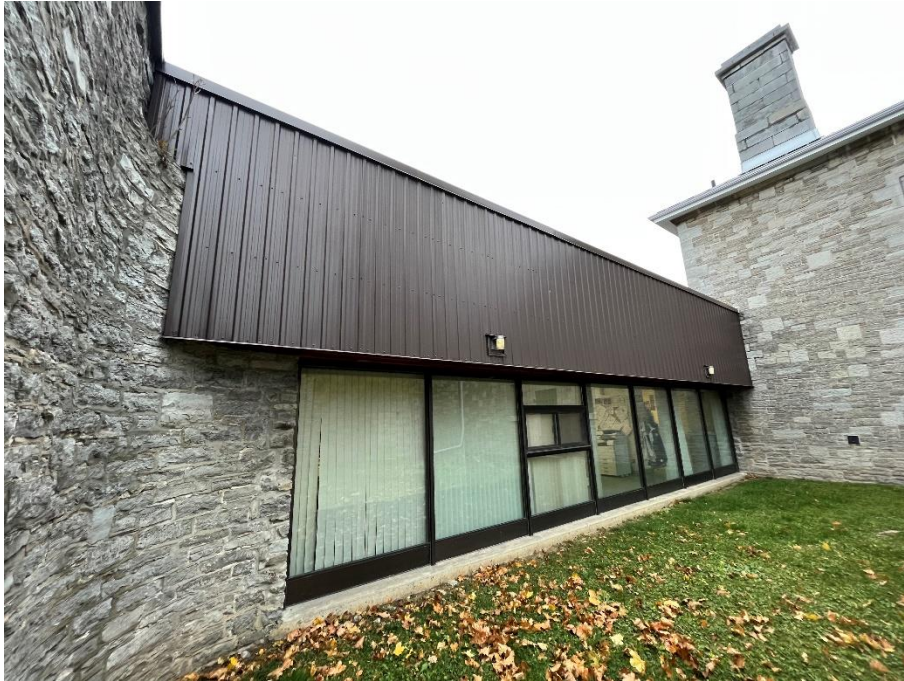
Figure 81: West elevation of the Land Registry Office from the south jail yard (A.S.I., 2023).

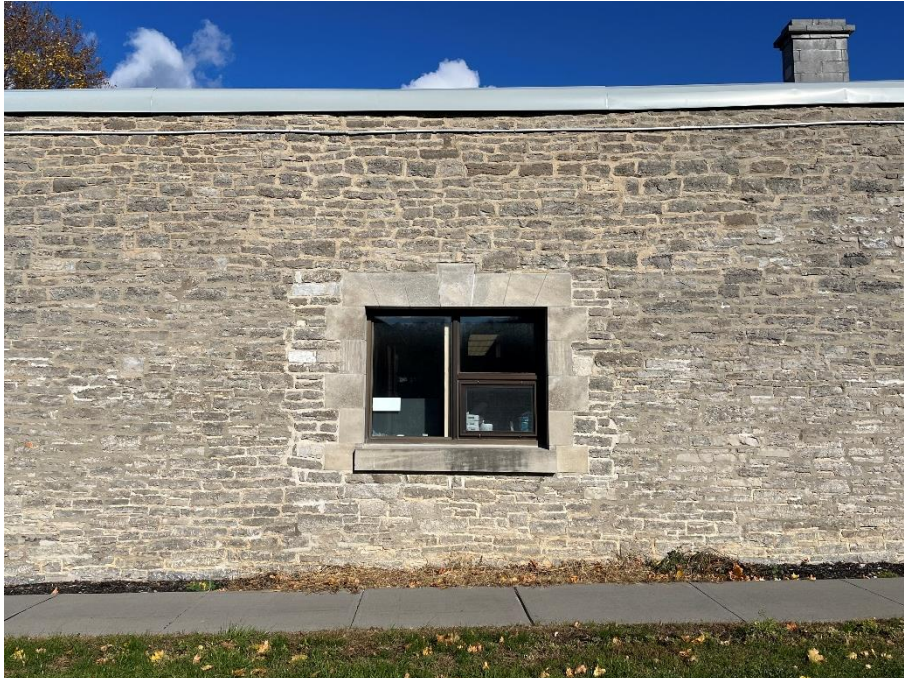
Figure 82: Detail of window added to the south jail yard wall when the Land Registry Office was constructed in 1975 (A.S.I., 2023)

A new Land Registry Office was constructed in the southwest corner of the jail yard in 1975 within the existing stone walls. The new building incorporated elements of the nineteenth-century jail into its design, with the main entrance being located at the arched entryway into the jail yard on the west wall (Figure 80). The one storey, flat roof building utilizes the west and south walls of the jail yard to define part of the office space. The remaining exterior walls are primarily glazed, providing expansive views into the former jail yard spaces (Figure 81). A window was added to the south wall of the jail yard as part of the Land Registry Office construction (Figure 82). The same year a one-storey addition of concrete block, faced with stone panels on its north elevation was added to the northeast corner of the courthouse (Figure 83). The chimneys on the east and west sides of the courthouse building were also removed from the roofline.

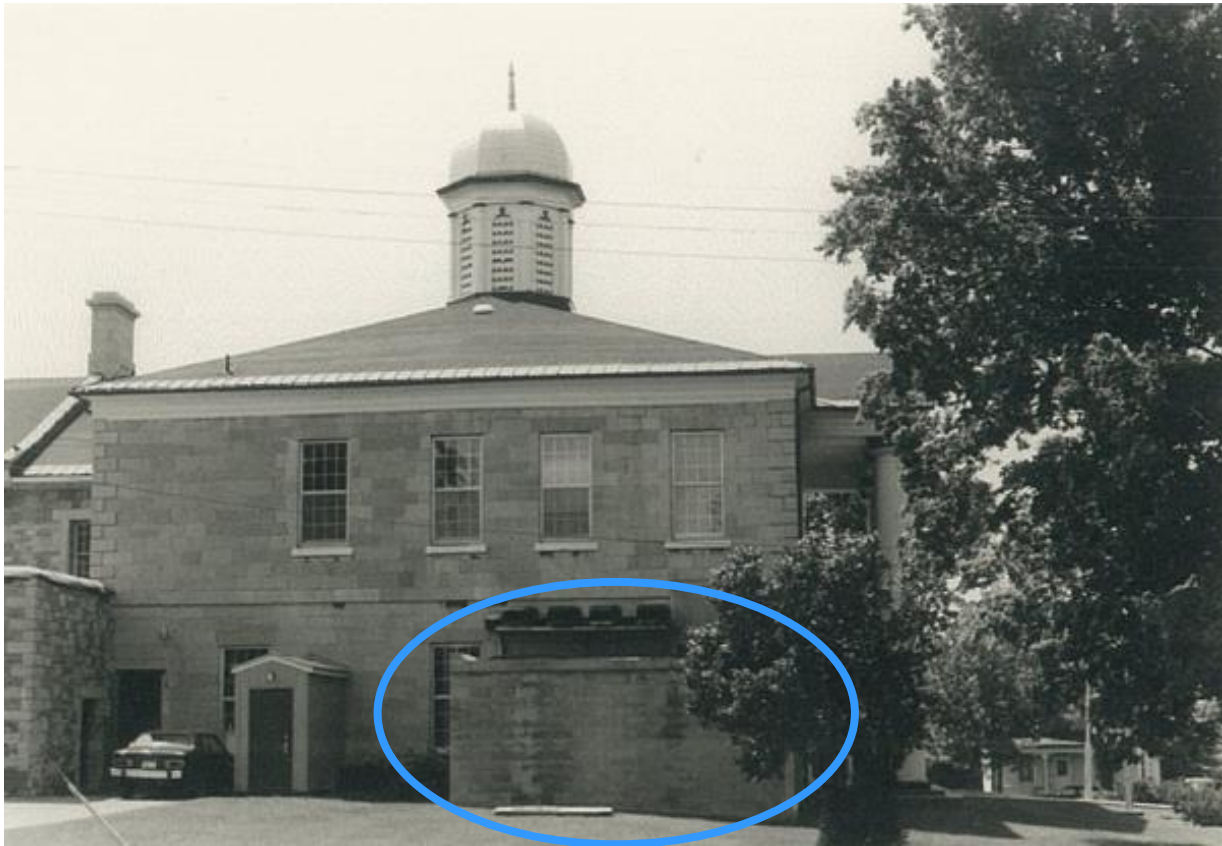
Figure 83: East elevation of the courthouse, pictured circa 1980, showing one-storey the concrete block (circled) (Prince Edward County Archives).

A small, one-storey addition built using concrete blocks on the east elevation of the courthouse. Based on the materials, design, and historical photographs of the property, it was likely constructed in the middle of the twentieth century. The north wall of the addition is clad with cut stone veneer and runs flush with the north-facing stone wall of the courthouse (Figure 36). The other minor addition on the east elevation is a small, metal-clad shed that provides cover for the basement access door.

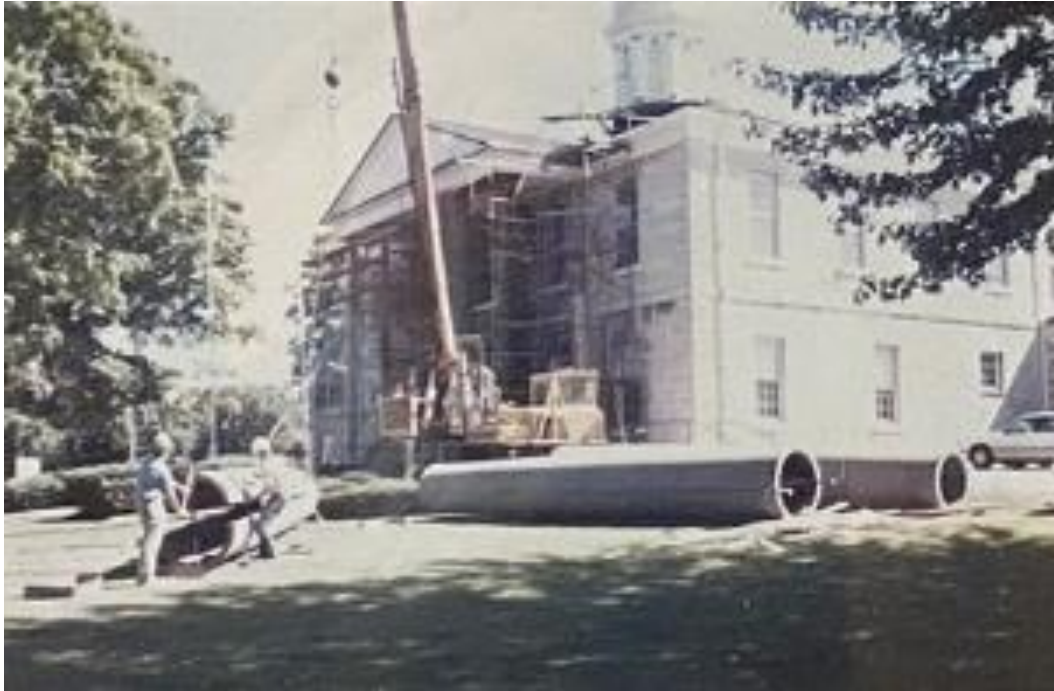
Figure 84: Replacement columns being prepared for installation within the portico of the courthouse in 1993 (Display board by M. O'lynn within the Picton Courthouse, documented by A.S.I., 2023).

The giant order wood columns supporting the portico on the north elevation of the courthouse were replaced with new wood columns in 1993 (Figure 84).

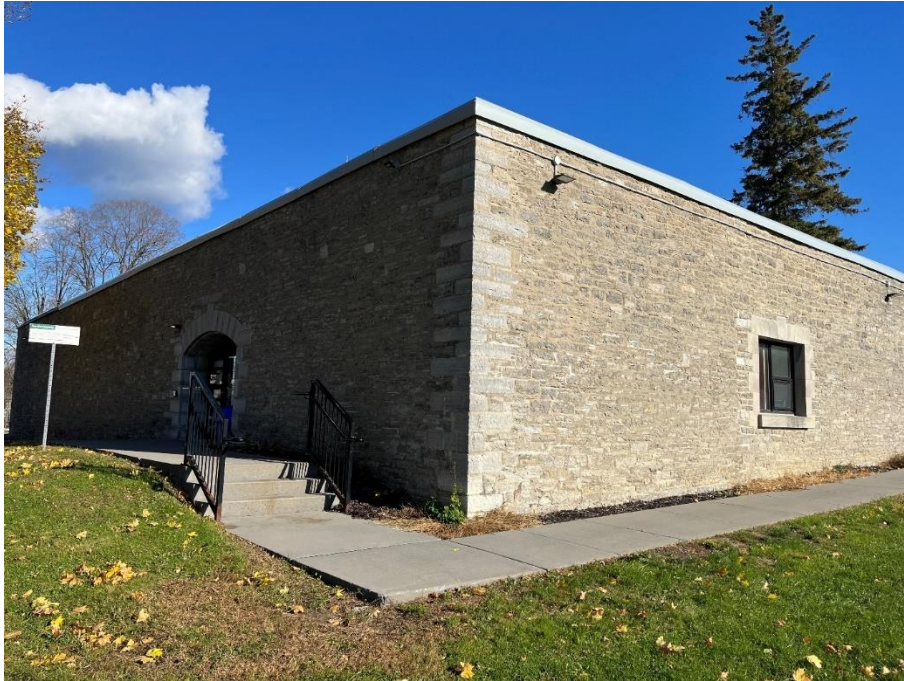
Figure 85: Detail of pedestrian walkway that connects the parking lots along the south side of the jail yard (A.S.I., 2023).

A sidewalk was added around 2012 to the south perimeter of the jail yard walls, connecting the two parking lots and the primary entrance to the Land Registry Office (Figure 85).

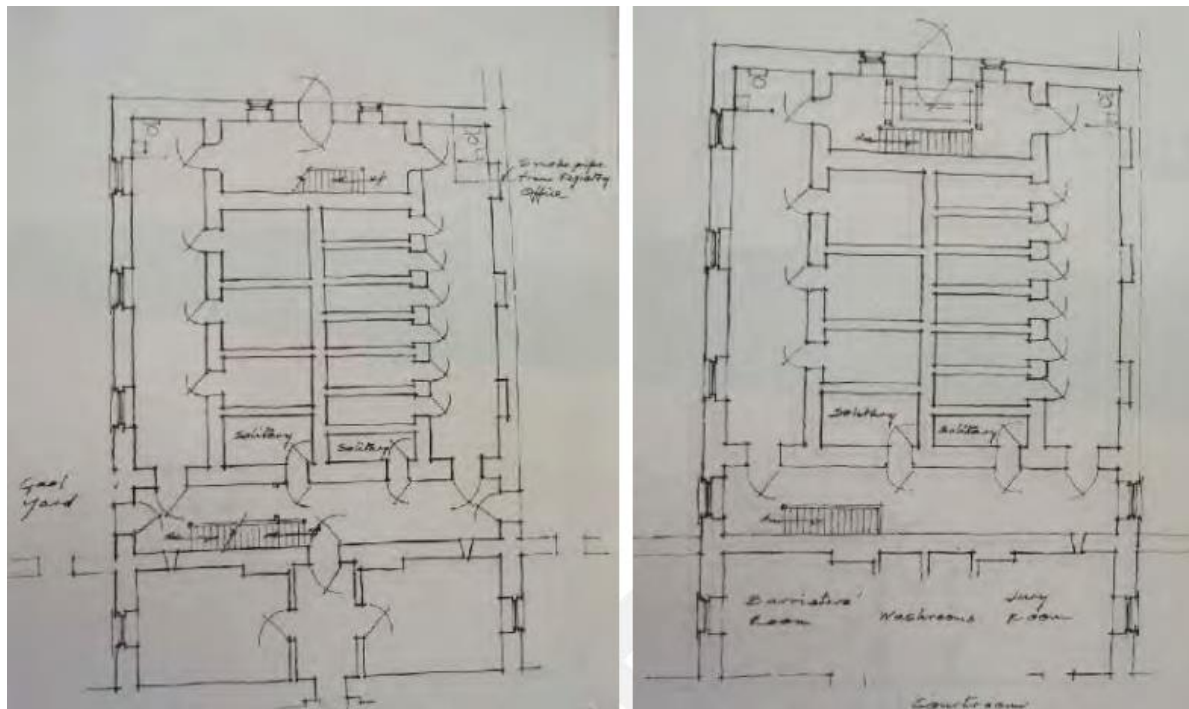
Figure 91: Sketch of the plans for the jail addition to the Picton Courthouse showing central cells and groupings of cells types, mirroring the model plans developed by the Board of Inspectors (Archives of Ontario).
